Manhole Inspection Summary

Manhole # S21CC_045MH

Insp Date: **10/24/07 10:52 AM**

Location Address: **1900 RIGGS AVE**

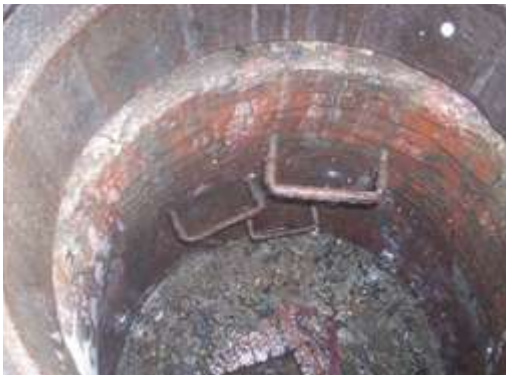
Defect 2

Count: **3** Missing: **0** ☒ **Corroded**

CORRODED STEPS

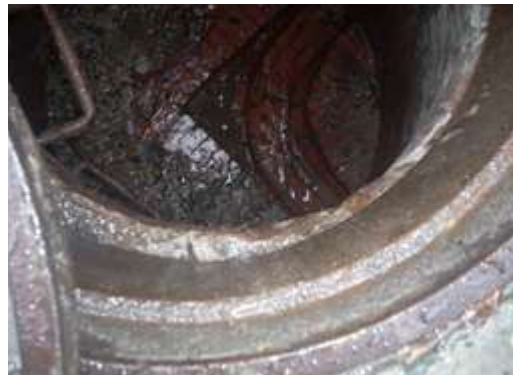
Defect 1

Offset: **1** (in.)

FRAME OFFSET

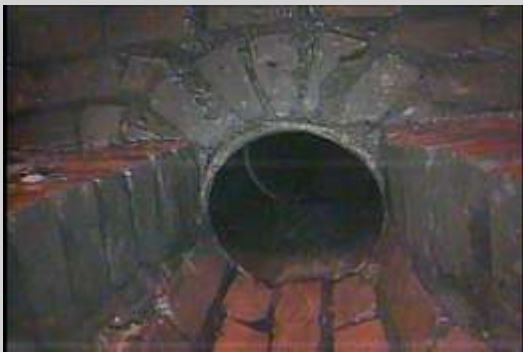
12 O'Clock Outflow

8 in. Circular Gravity Sewer
Pipe Out @ 12 O'Clock

Pipe Height: **8.4** (in.) Rod and Bar (Angled)
Pipe Material: **Clay** ☐ Pipe Lined
Invert Depth: **6.77** (ft.) Flow Characteristics: **Slow**
Deposits: ☒ None ☐ Mud ☐ Sludge ☐ Debris ☐ Grease
Silt Depth: (in.) Deposits Extent:
Infiltration: **None** Pipe Seal Cond: **Sound**

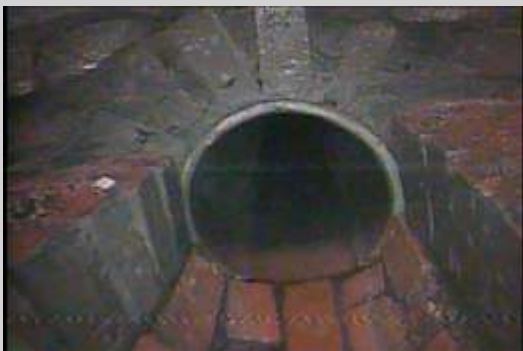
3 O'Clock Inflow

8 in. Circular Gravity Sewer
Pipe In @ 3 O'Clock

Pipe Height: **8.4** (in.) Rod and Bar (Angled)
Pipe Material: **Clay** ☐ Pipe Lined
Invert Depth: **6.60** (ft.) Flow Characteristics: **Slow**
Deposits: ☒ None ☐ Mud ☐ Sludge ☐ Debris ☐ Grease
Silt Depth: (in.) Deposits Extent:
Infiltration: **None** Pipe Seal Cond: **Sound**
